Department of Industrial Engineering

Rehab Equipment Space & Inventory Assessment

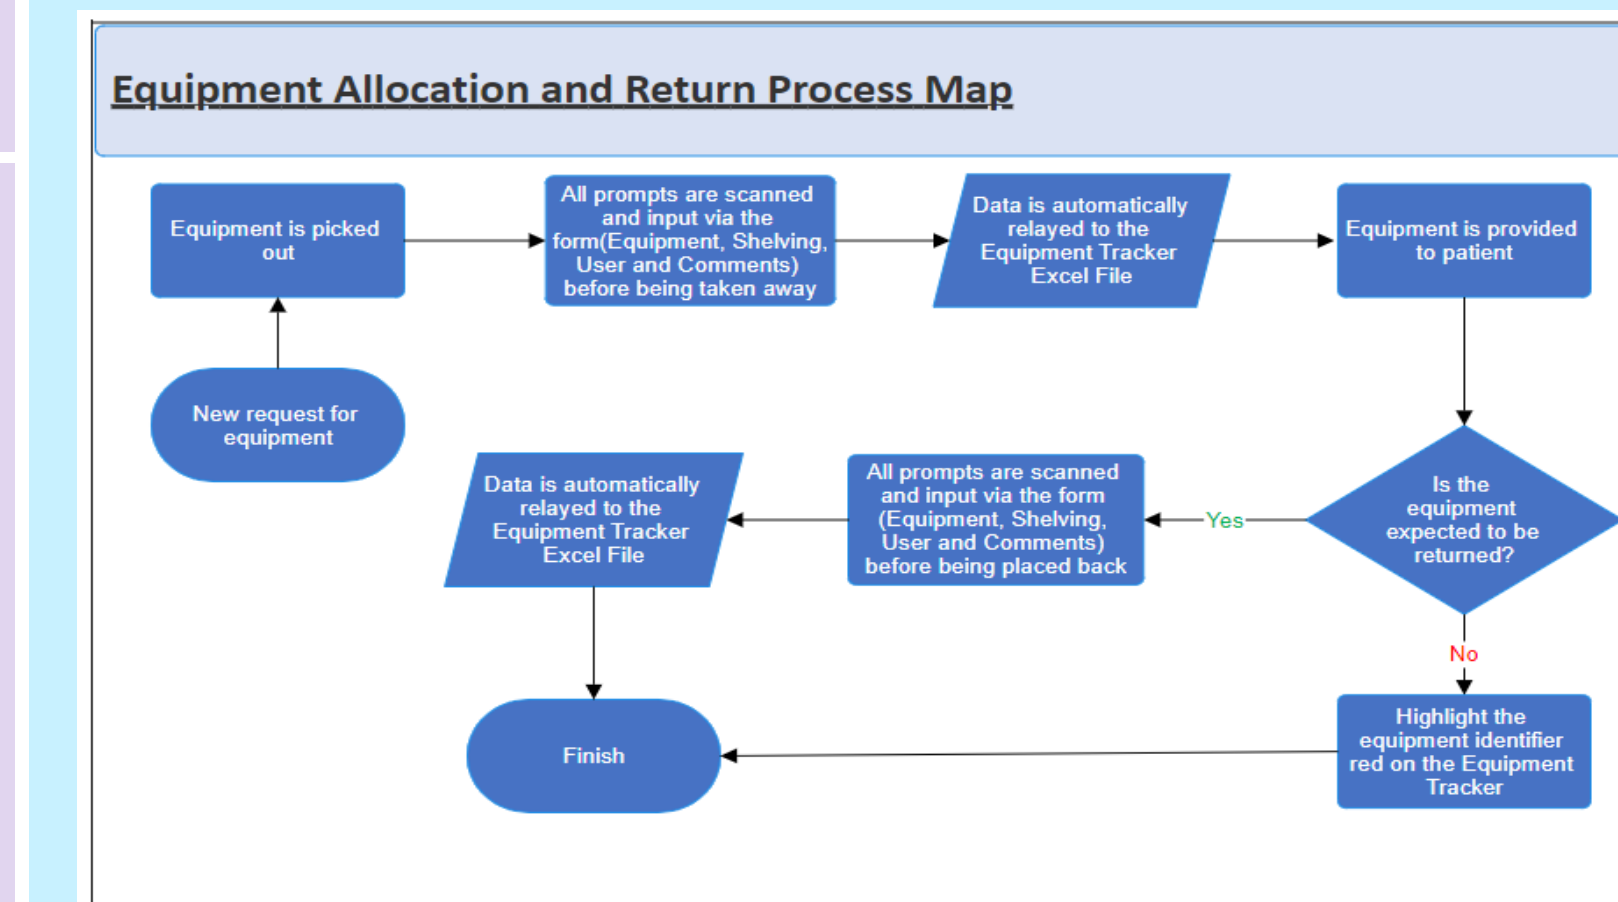
Power BI User Interface

- User input form created via an external application that relays and logs equipment information to Excel file.
- A flat file is created where the log is filtered to show the most recent information of the equipment.
- Slicers and filters are utilized to create an effective and user-friendly interface via Power BI.

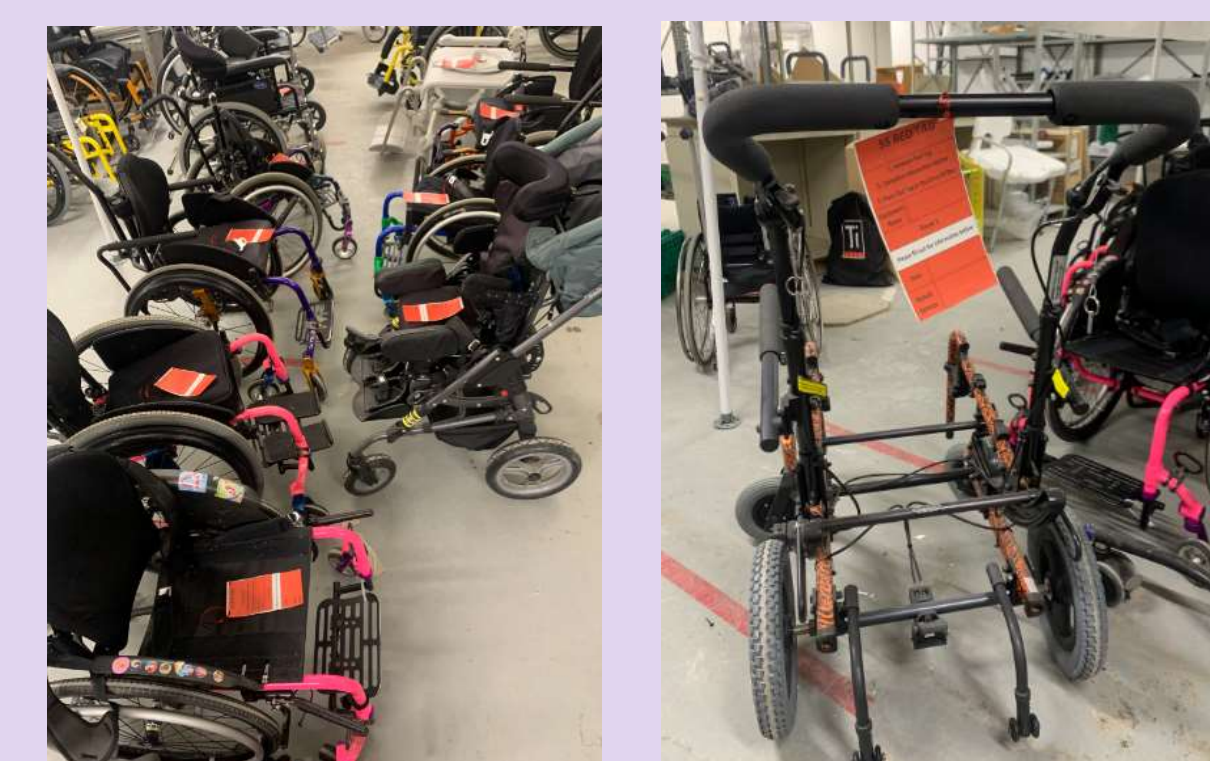
Example of Red Tagged equipment

- Background:** 5S is a methodology aimed at organizing an area to enhance efficiency and operations.
- Benefits:** Successful implementation leads to increased visual management, improved operational standards, and reduced operational waste.
- Equipment Red Tagging Trail:** The purpose of the red-tagging trial is to assess equipment usage, identify deadstock items and improve storage space within the Rehab Services storage area.
- Methods:** Applied red tags to all equipment in Room 2. Established a drop box, process maps and checklists to communicate steps with frontline workers for a trial period of 14 days.
