Dalhousie University, Department of Facilities Management

Confined Space Inventory Form

Building: MacDonald (?) C400	Room Number: <u>Hallway</u>	Date: June 13, 2013		
Confined Space No: <u>C400 – HW – 01</u>	Confined Space Class:			
Description of Space: This space is located in the basement off the men's washroom. Enter the building through the double doors between MacDonald and Chemistry buildings and go down to basement.				
Utilities in tunnel are domestic hot water, steam, electrical (not high voltage), hot water heating, condensate lines and sprinkler lines.				
Method of Entry: Crawl into tunnel. No. of Access / Egress Points: 1				
Dimensions of Access / Egress Opening: THESE DIMENSIONS ARE FOR THE DORWAY IN Photo 2013 – 06 – 1322				
Height: <u>56.0 inches</u> Width: <u>35.0 inches</u> D	epth: 00.0 ft. approx. Diamet	er: <u>00.0 inches</u>		
Type of Work Normally Conducted in Space: <u>Repairs to or replacing of pipes and electrical lines.</u>				
Frequency of Work Performance: <u>As required.</u>

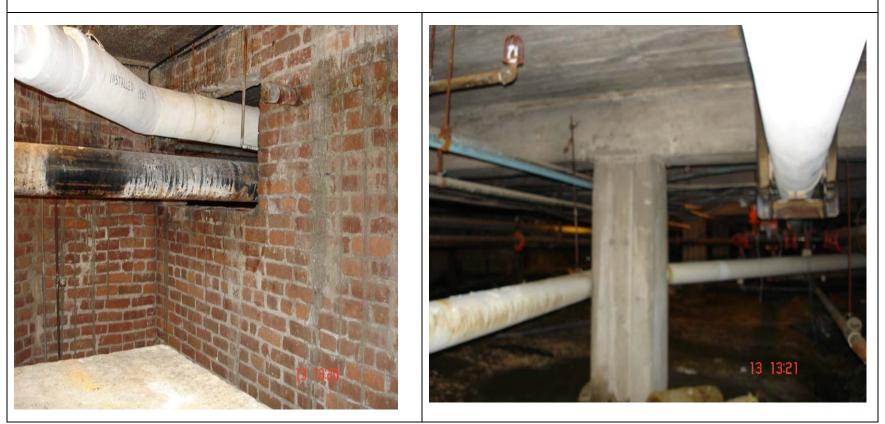
Photo Numbers: <u>2013 – 06 – 13 (1321)</u>

Potential Hazards List all hazards near the access / egress opening(s) or in the confined space that must be controlled to ensure employee safety.				
Oxygen Hazard:				
Electrical Hazards:				
Electrical lines	Isolate all unnecessary electrical circuits and lock out. Keep			
	equipment power cords out of water.			
Mechanical Hazards:

Physical Hazards: Protruding pies, High pressure steam Water Condensate	Isolate all energy sources and lock out.
Chemicals Hazards:	
Biological:	
Additional Comments:

Photo 2013 - 06 - 13(1321)(02) is the view as seen through the opening in Photo 2013 - 06 - 13(1321).

The doorway shown in Photo 2013 - 06 - 1322 can provide access to the space although the floor level of the space is 24 inches above the floor level of the hallway. Crawling is the only way to move around in the space.
