Dalhousie University, Department of Facilities Management

Confined Space Inventory Form

Building: Student Union Bldg. E100	Room Number: 070	Date: June 18, 2013	
Confined Space No: <u>D420 – RCR – 01</u>	Confined Space Class:		
Description of Space:			
Domestic hot water storage tank.	(Mechanical Room)		
Construction Material: Concrete with a steel cover.			
Method of Entry: Access by ladder. No. of Access / Egress Points: 1			
Dimensions of Access / Egress Opening:			
Length: 0.0 ft. Width: 0.0 ft. Depth:	Diameter:		
Type of Work Normally Conducted in Space: Repairing or replacing concrete lining.			
Frequency of Work Performance: <u>As required.</u>			
Reference Atmospheric Testing: CO ppm	H ₂ S ppm O ₂ <u>20.</u>	<u>8_</u> % LEL%	
Other:

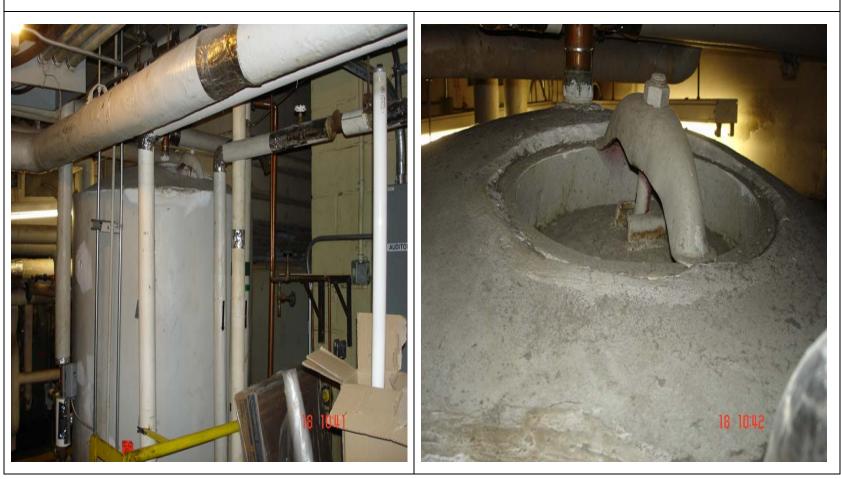
<u>2013 - 06 - 18 (1042)</u>

Potential Hazards List all hazards near the access / egress opening(s) or in the confined space that must be controlled to ensure employee safety.		
Oxygen Hazard:		
An oxygen deficient atmosphere could exist.	Test O ² levels and ventilate as required	
Electrical Hazards:		
Mechanical Hazards:

Physical Hazards:	
Concrete may contain asbestos.	Test concrete for asbestos and implement appropriate control measures.
Chemicals Hazards:	
Flammables:	
Additional Comments:
