**Dalhousie University, Department of Facilities Management**

**Confined Space Inventory Form**

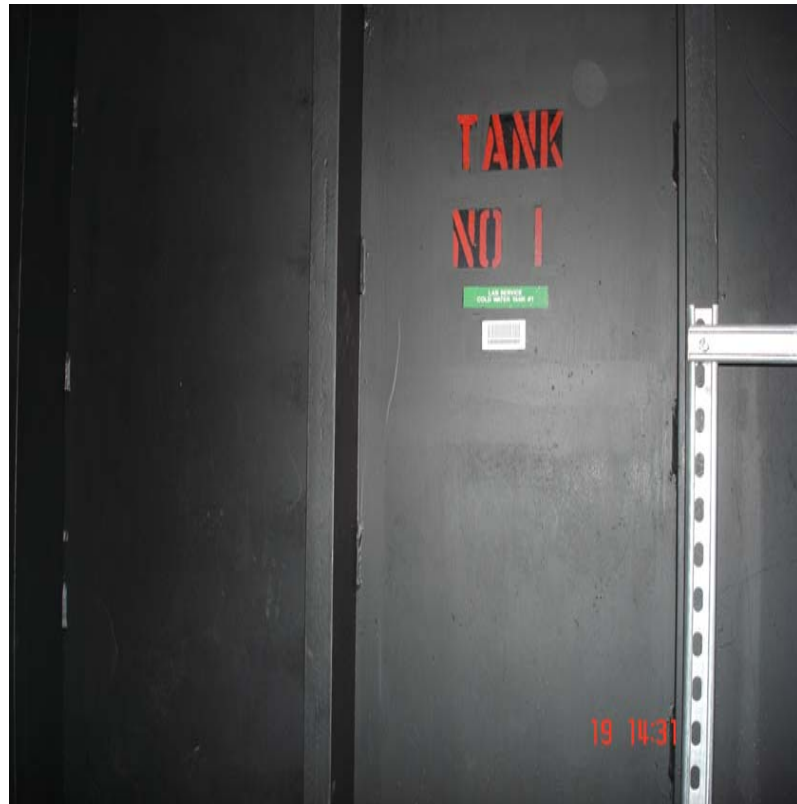
Photo Numbers: 2013 - 06 - 19 (1431)

Building: <u>Tupper F200</u>	Room Number: <u>PH</u>	Date: <u>June 19, 2013</u>
Confined Space No: <u>F200 – PH – 03</u>	Confined Space Class: _____	
Description of Space: <u>Lab Services Cold Water Tank #1</u>		
Construction Material: <u>Steel</u> <u>Unsure of internal surface.</u>		
Method of Entry: <u>Ladder required to access hatch on top of tank. Second ladder required to go into tank.</u> No. of Access / Egress Points: <u>1</u>		
Dimensions of Access / Egress Opening:		
Length: <u>00.0 inches</u> Width: <u>00.0 inches</u> Depth: <u>00.0 ft. approx.</u> Diameter: <u>00.0 inches</u>		
Type of Work Normally Conducted in Space: <u>Maintenance of tank and / or resurfacing of inside.</u>		
Frequency of Work Performance: <u>As required.</u>		
Reference Atmospheric Testing: CO _____ ppm    H <sub>2</sub> S _____ ppm    O <sub>2</sub> _____ %    LEL _____ %		
Other: _____
