INTRODUCTION

Queensland beach is a popular barrier beach near Halifax, Nova Scotia. The beach is accessed via Conrads Road which runs adjacent to the beach. Due to its proximity to the water, Conrads Road has been damaged and washed out several times over the years by severe storms due to insufficient protection. Our group was tasked with redesigning the coastal protection for Conrads Road while preserving the integrity of the beach.

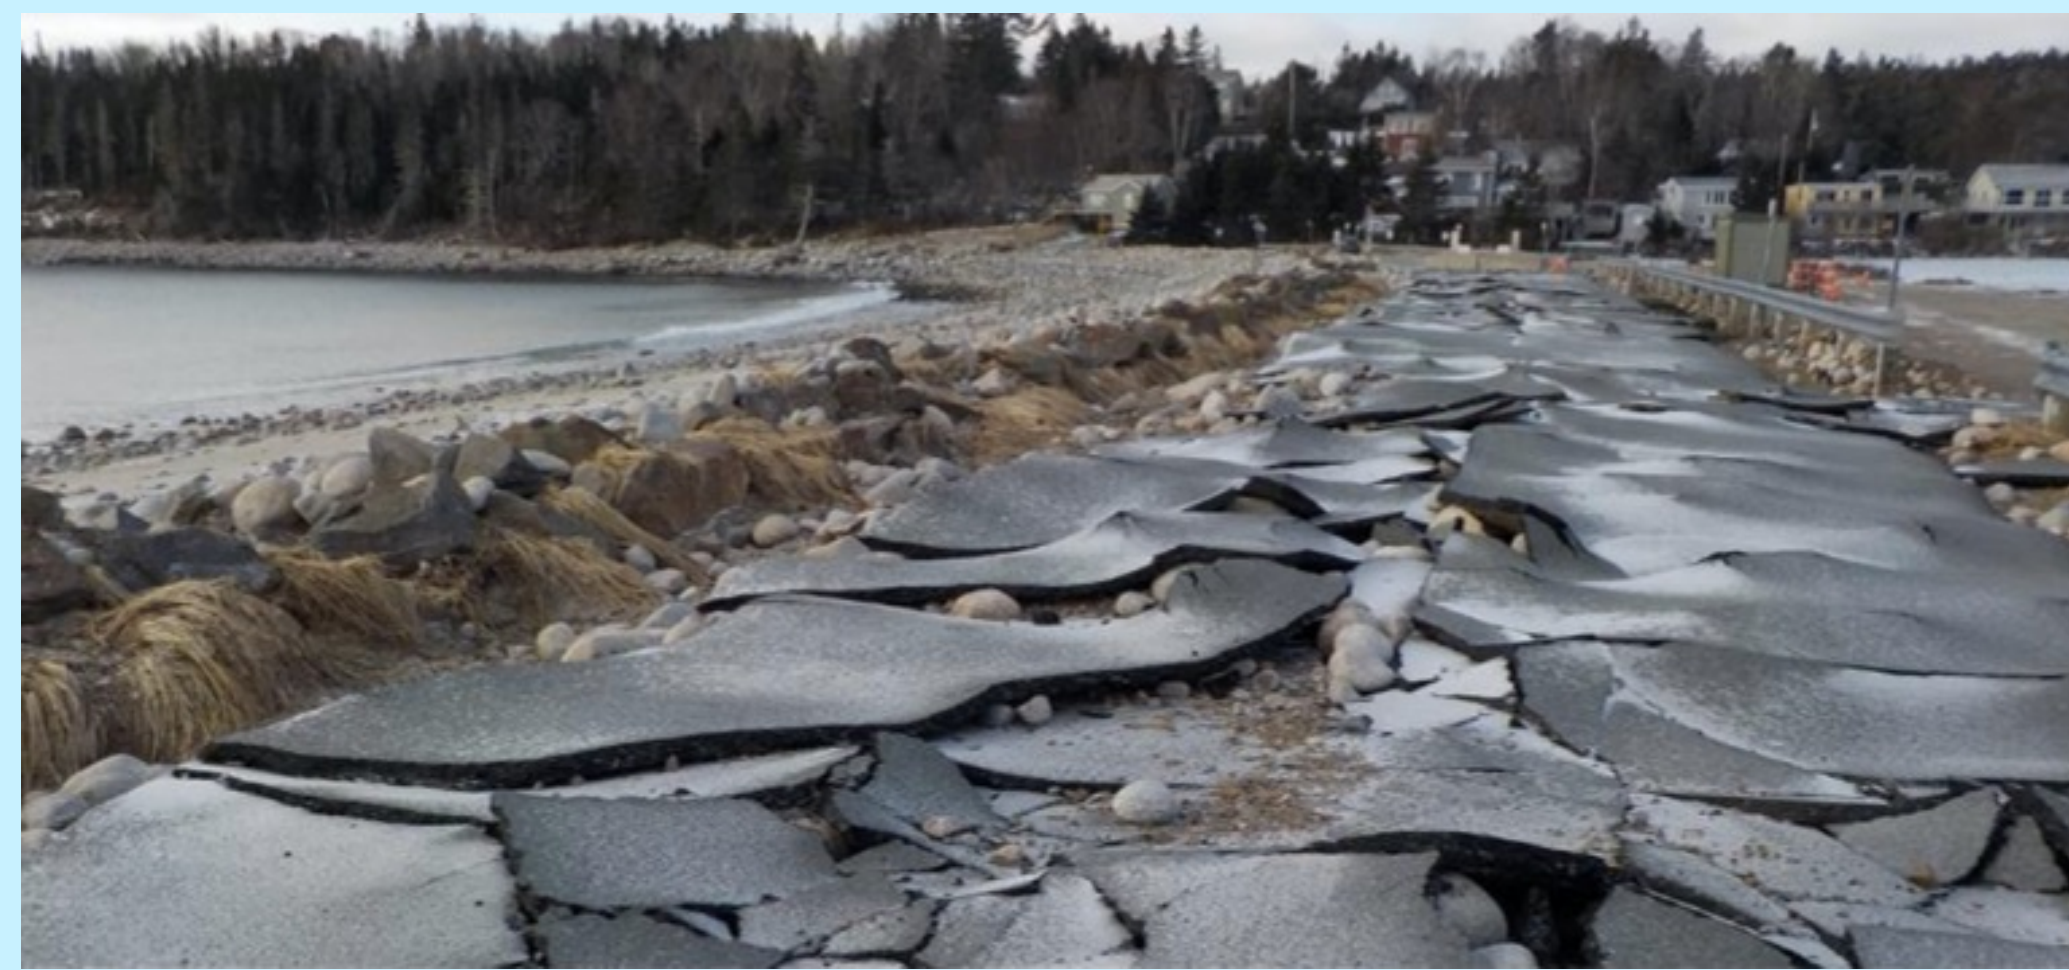
Figure 1. January 2018 winter damage to Conrads Road.

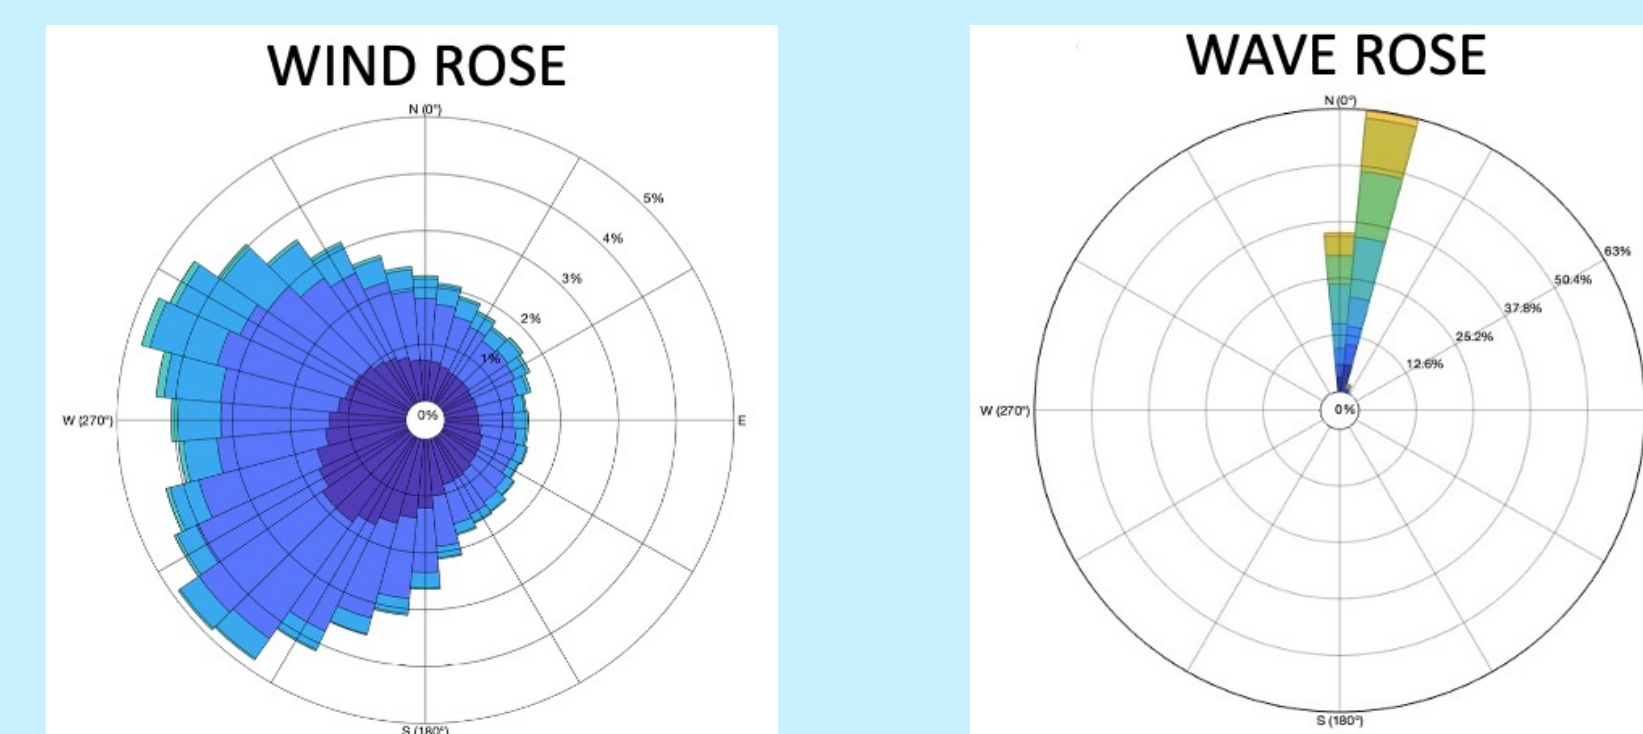
Figure 3. Plotted offshore wind and wave data.

Offshore wind/wave data was analyzed to determine offshore wave heights and the conditions of the most severe storms. This information was converted into wave conditions at the shore using the wave modelling software SWAN1D. Due to climate change it is expected that not only will there be an increase in mean water levels but also an increase in storm frequency and magnitude.

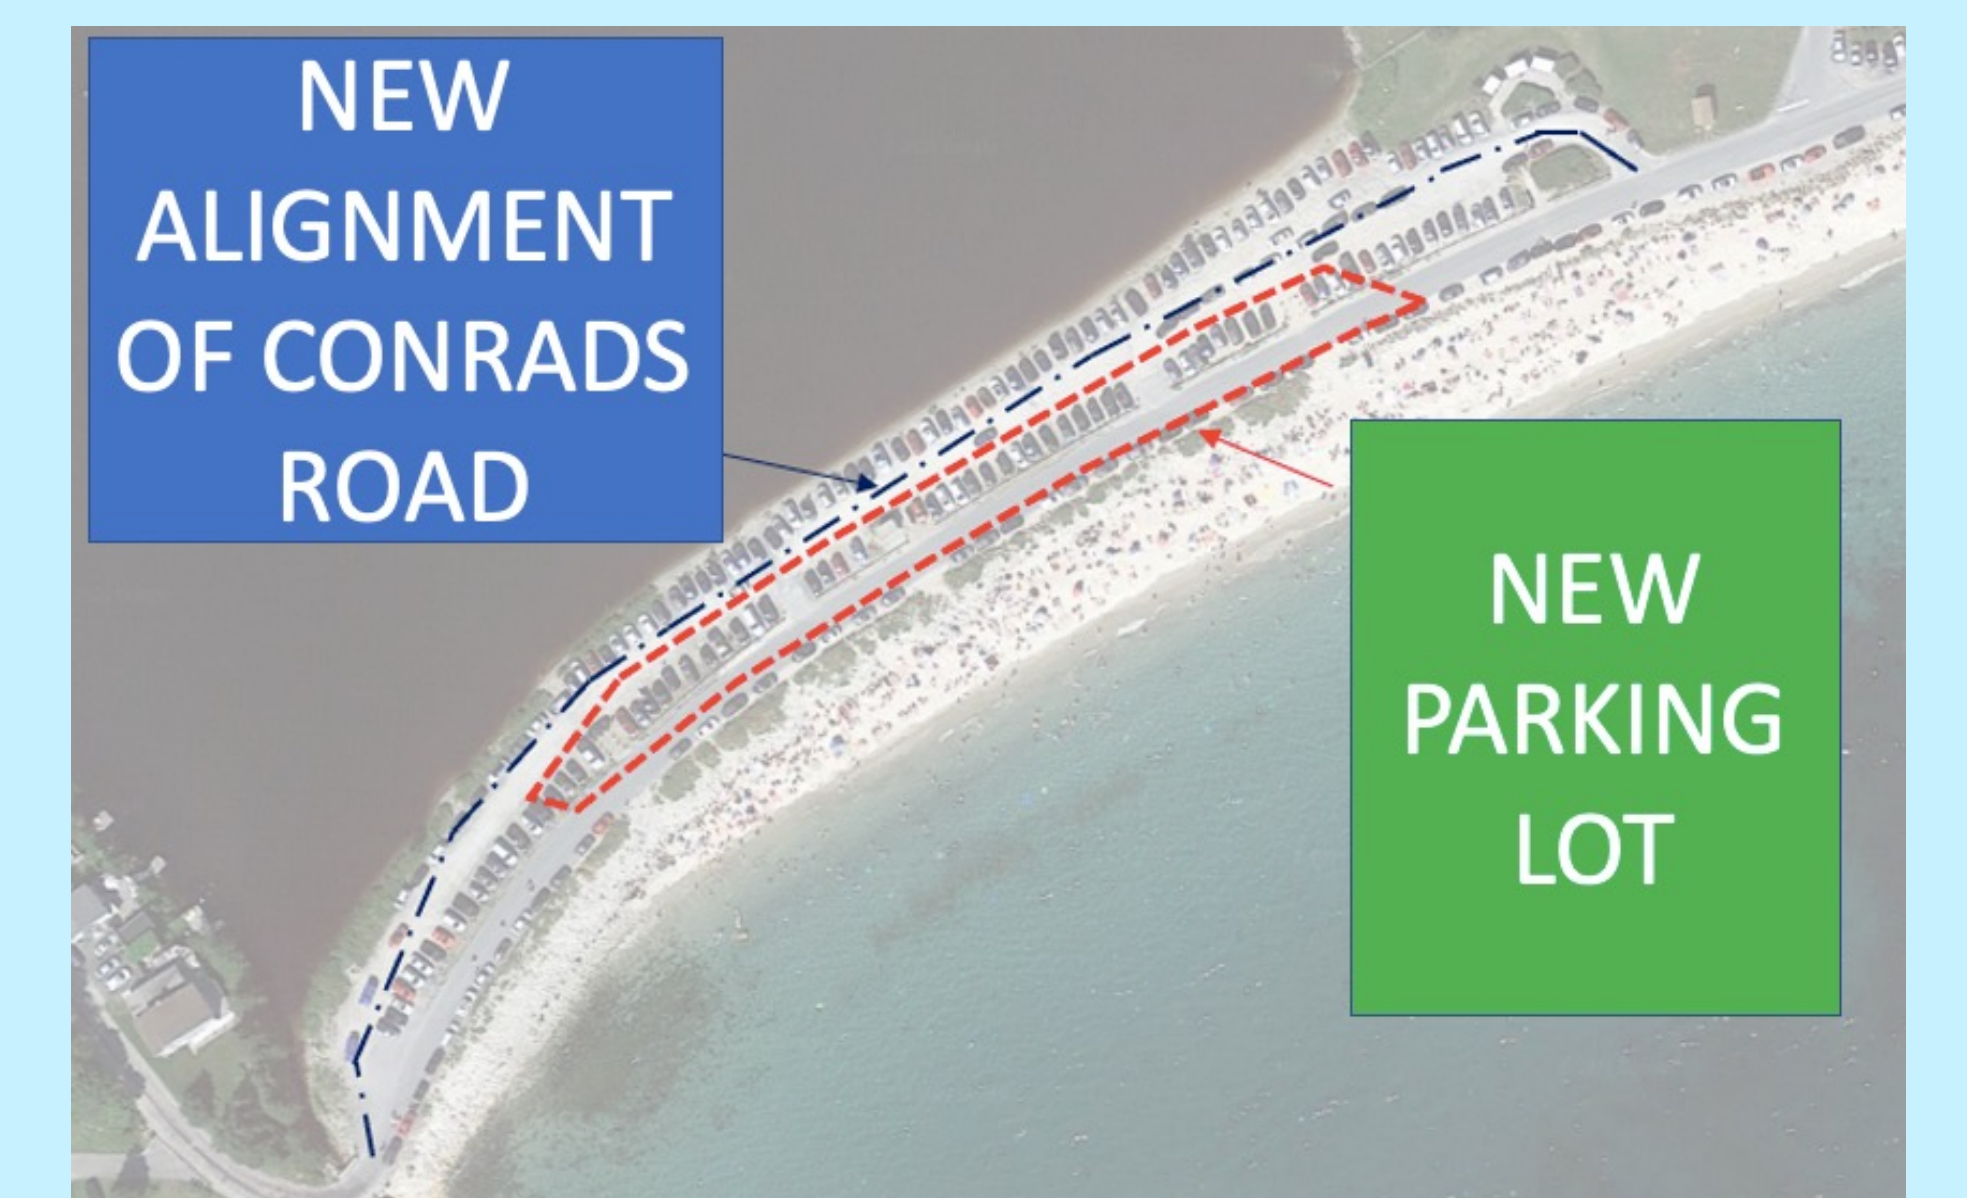
Figure 9. New road and parking design.
