# Geotechnical Design for Stewiacke Flood Control

## Introduction

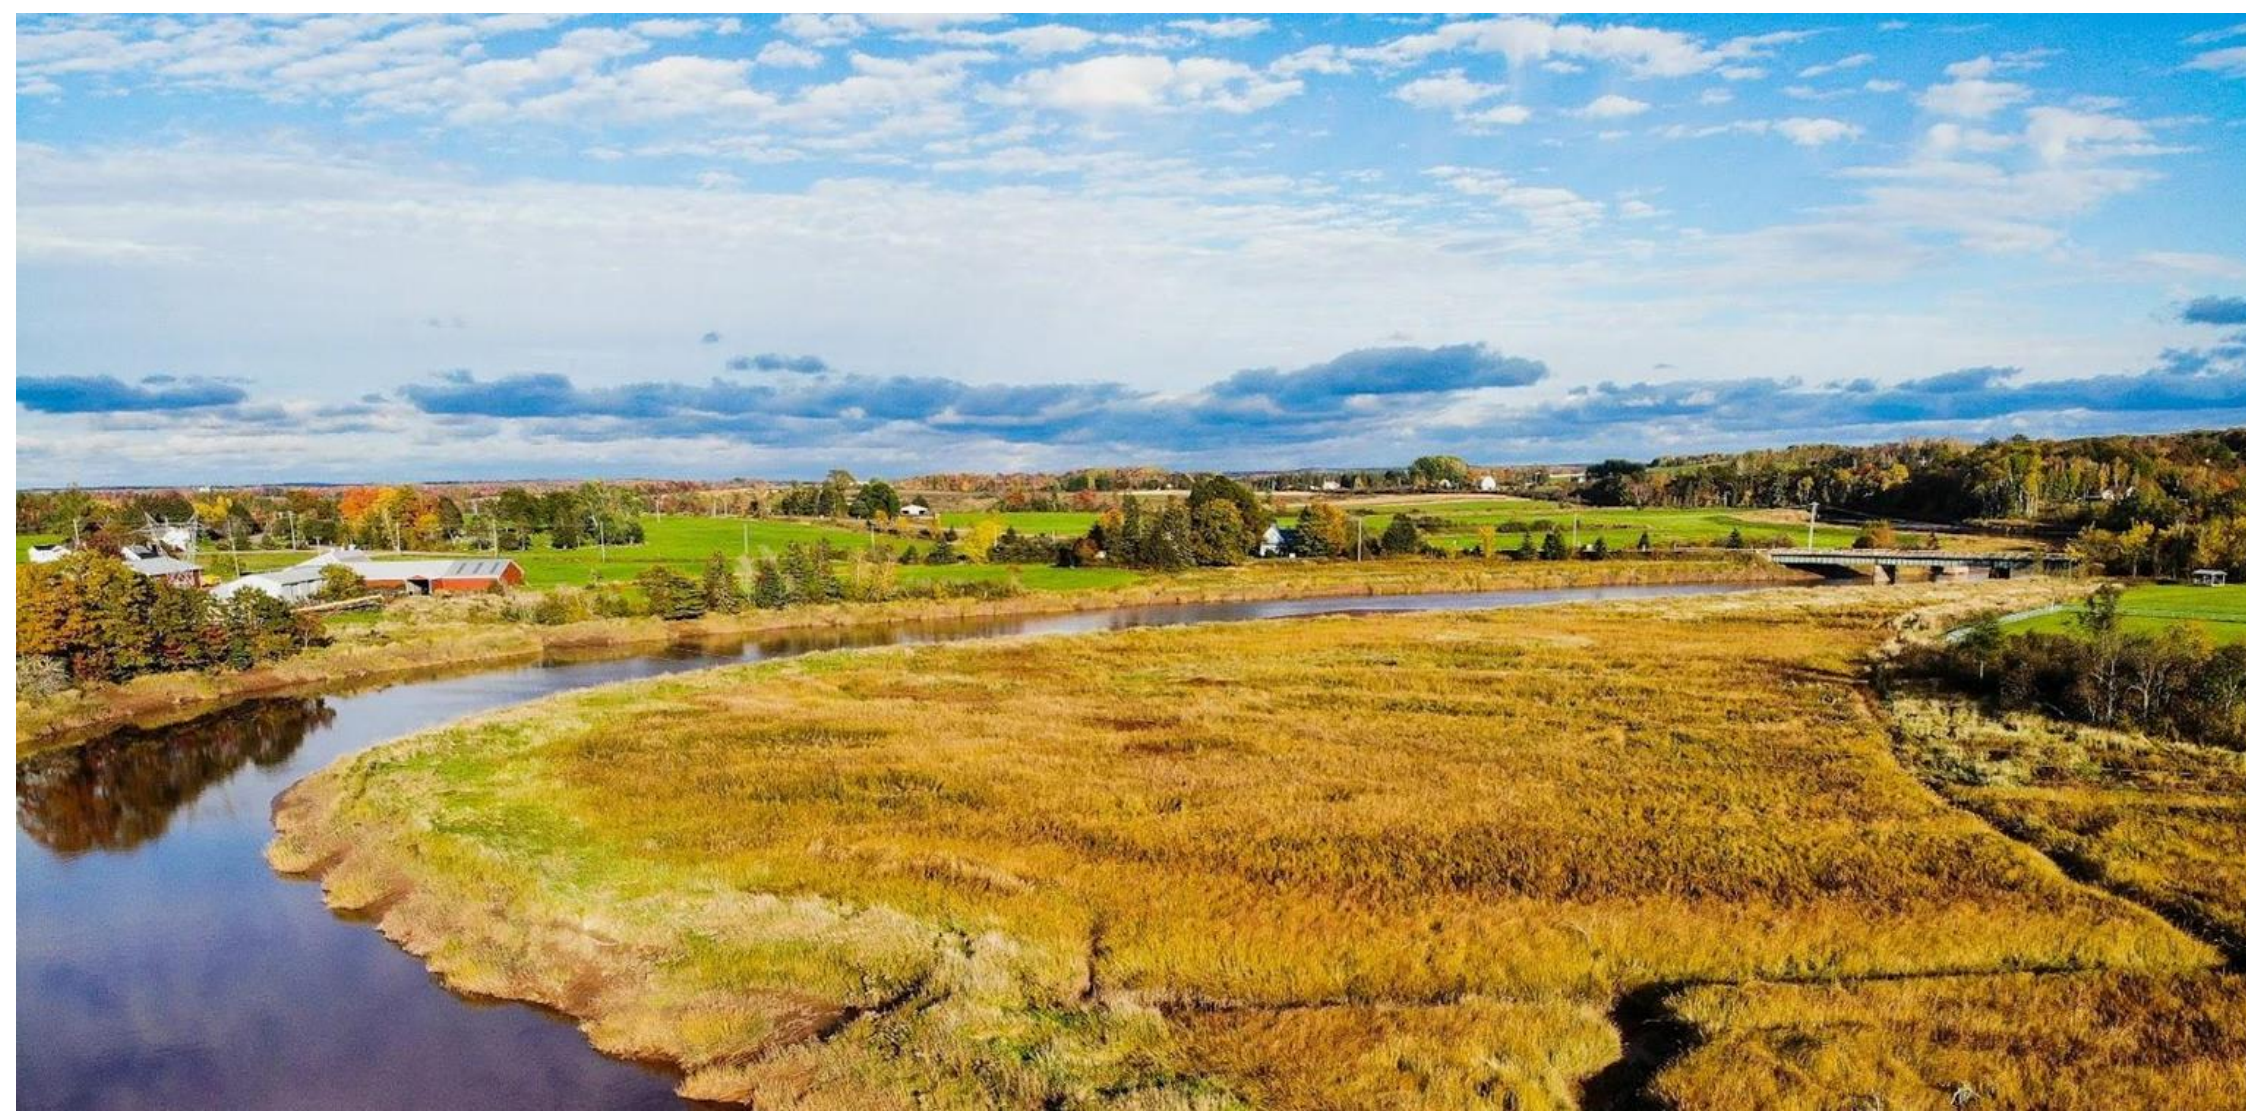
- Flooding of recreational area near on the Stewiacke River.
- 2ft floods over the ball field, dog park, and start of walking trail.
- The current dyke has not been maintained and is insufficient to prevent flooding.
- An image of the current dyke is shown below.

- The dyke does not have a maintained flood plain or defined ridge required to function properly.
- Soil conditions in the area are soft and must be considered when determining cross sections of the soil layers for stability analysis.
- Understanding the maximum flood height and effects on the recreational facilities. A flood simulation is shown below.

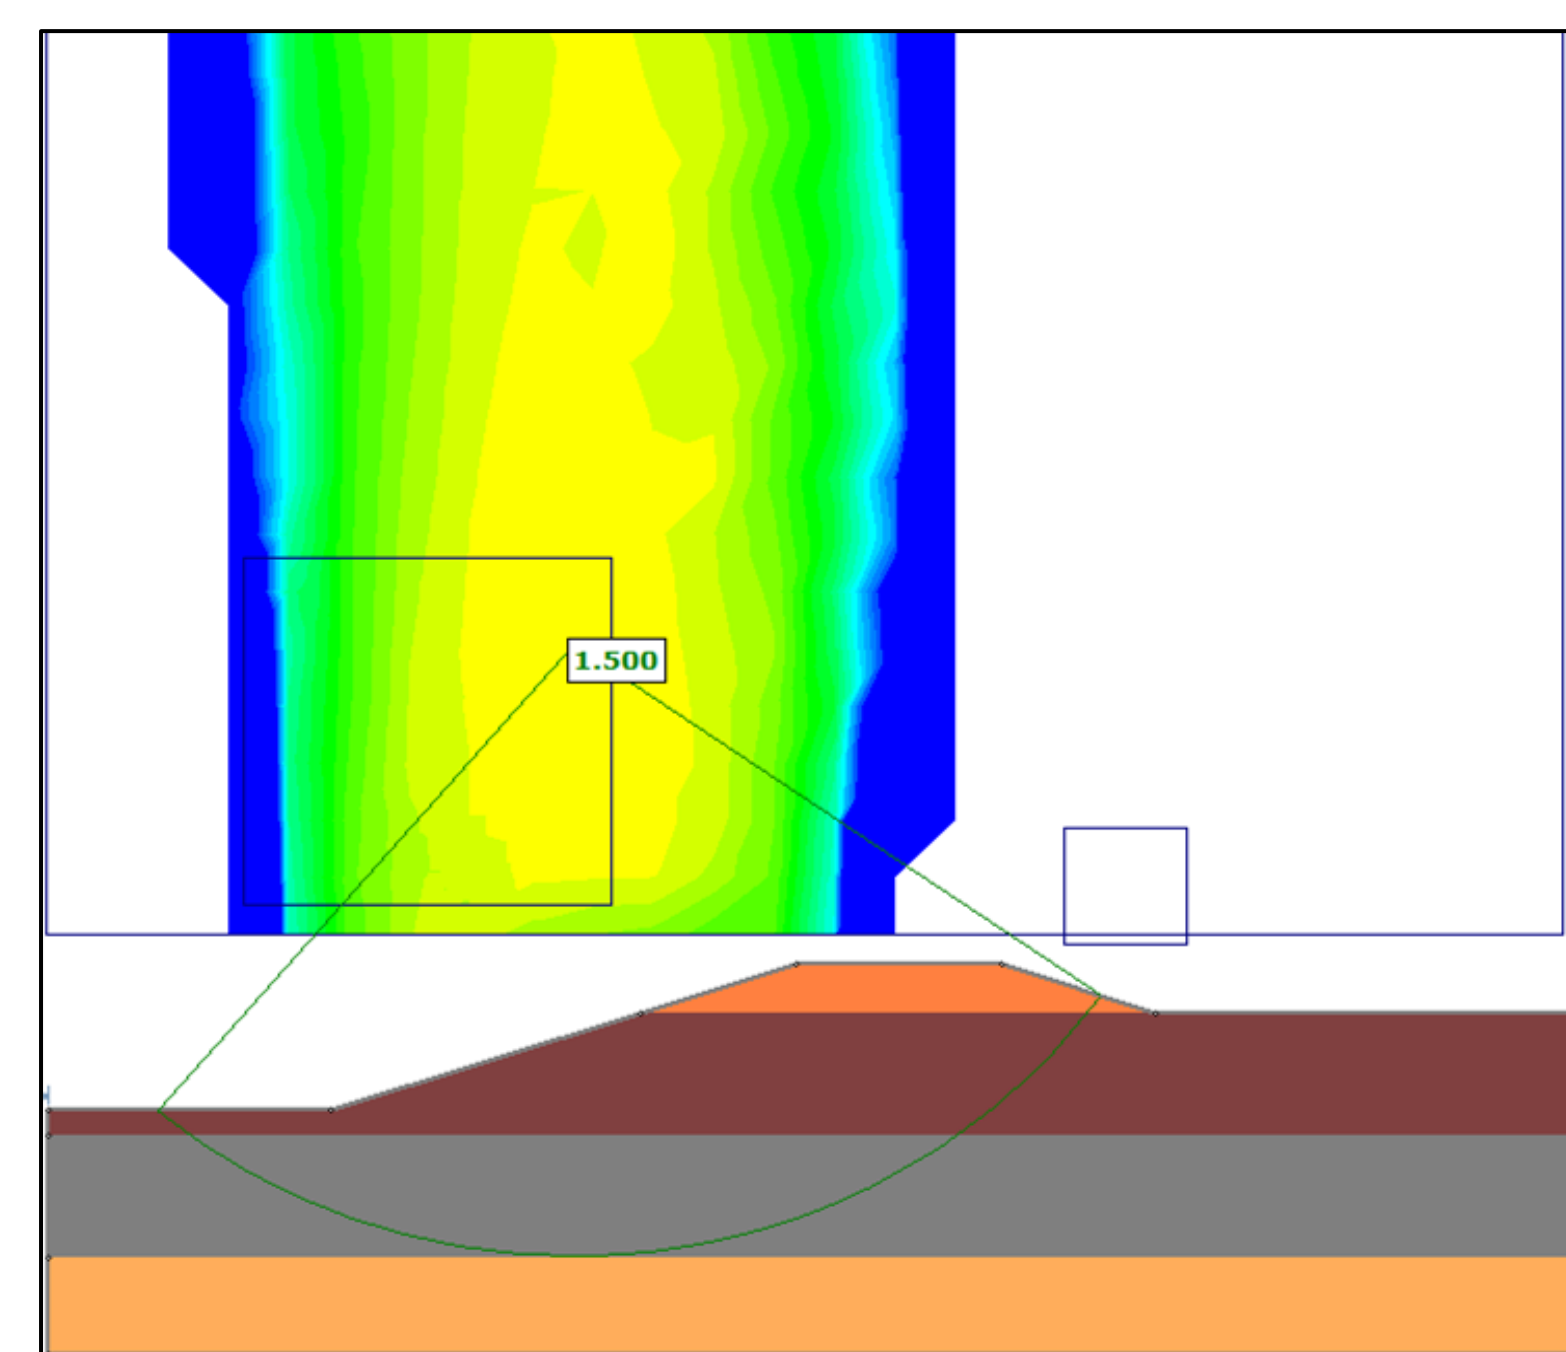
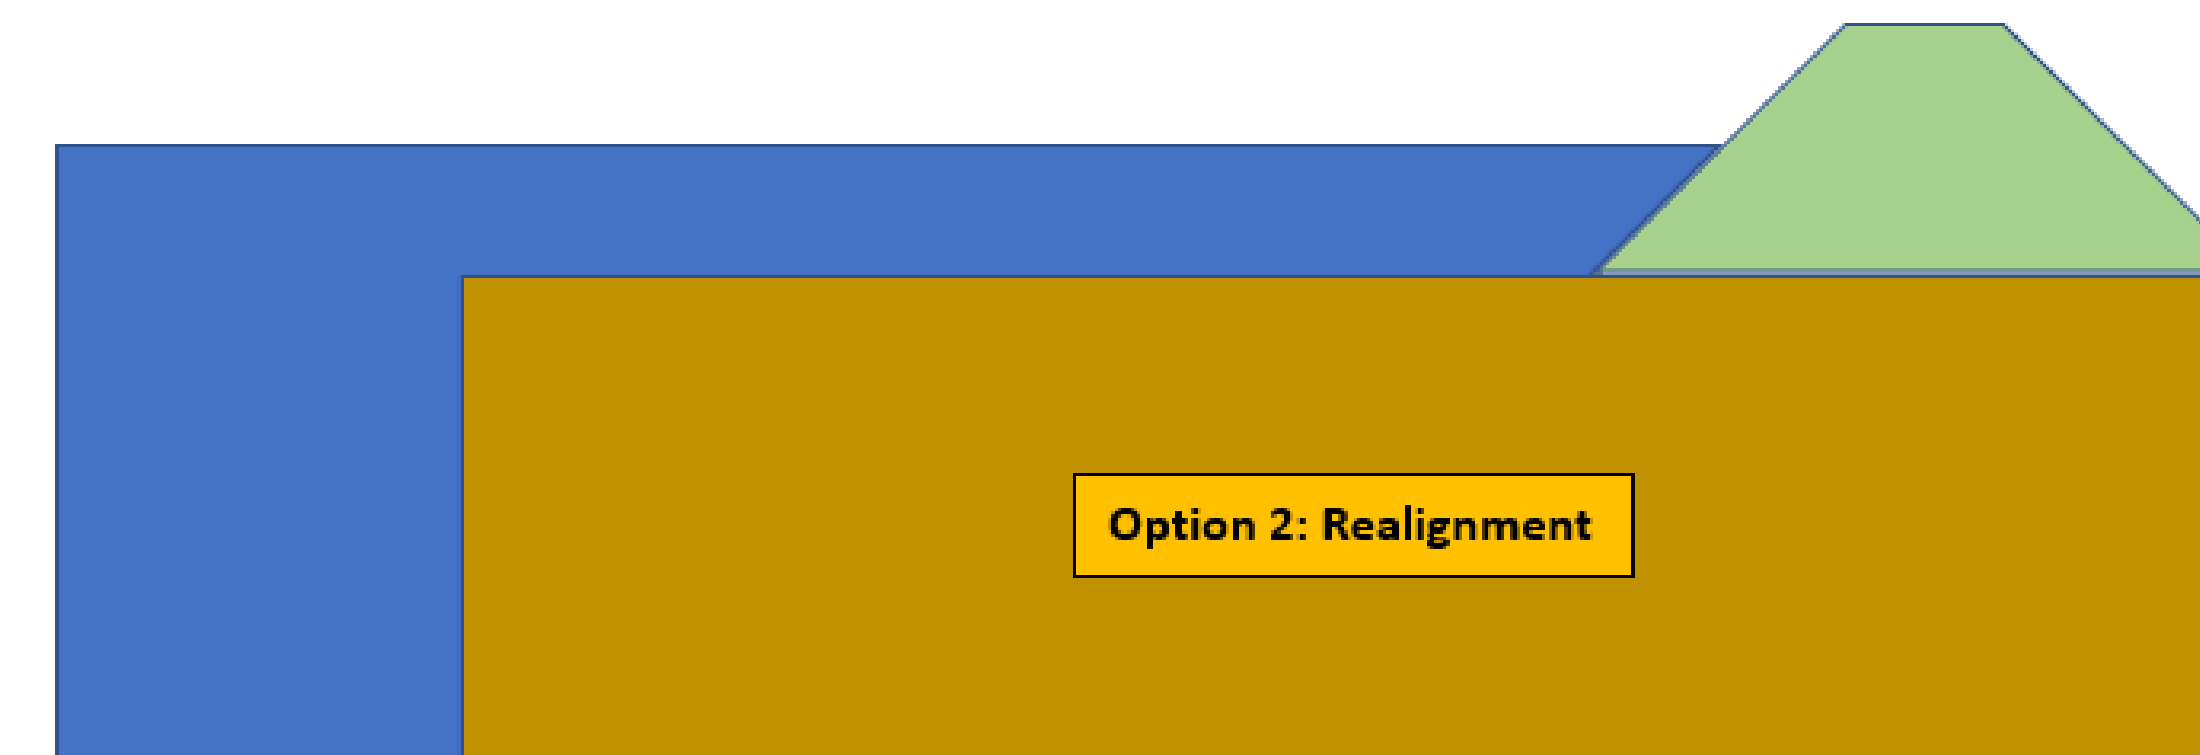
- The drained analysis for Cross Section 1 had the lowest FOS=2.004 with a 3:1 slope.
- Attempted a 2:1 slope facing the water, however, the slope failed with a FOS=1.156.

- The maximum water level was assumed to 9m in elevation. It was later confirmed to be 8.3m.
- The drained and undrained conditions needed to be tested to ensure stability throughout construction.
- The minimum FOS is greater than 1.5.
- One cross-section was used for the rehabilitation design.
- three potential cross-sections were required for the relocation design since it has varying elevations.
- 2:1 slopes were attempted on the land side of the dykes but they were insufficient.
- 3:1 slopes were determined to be sufficient.
- Both design options do not need staged construction.
- Crest elevations are 10m and crest widths are 8m.

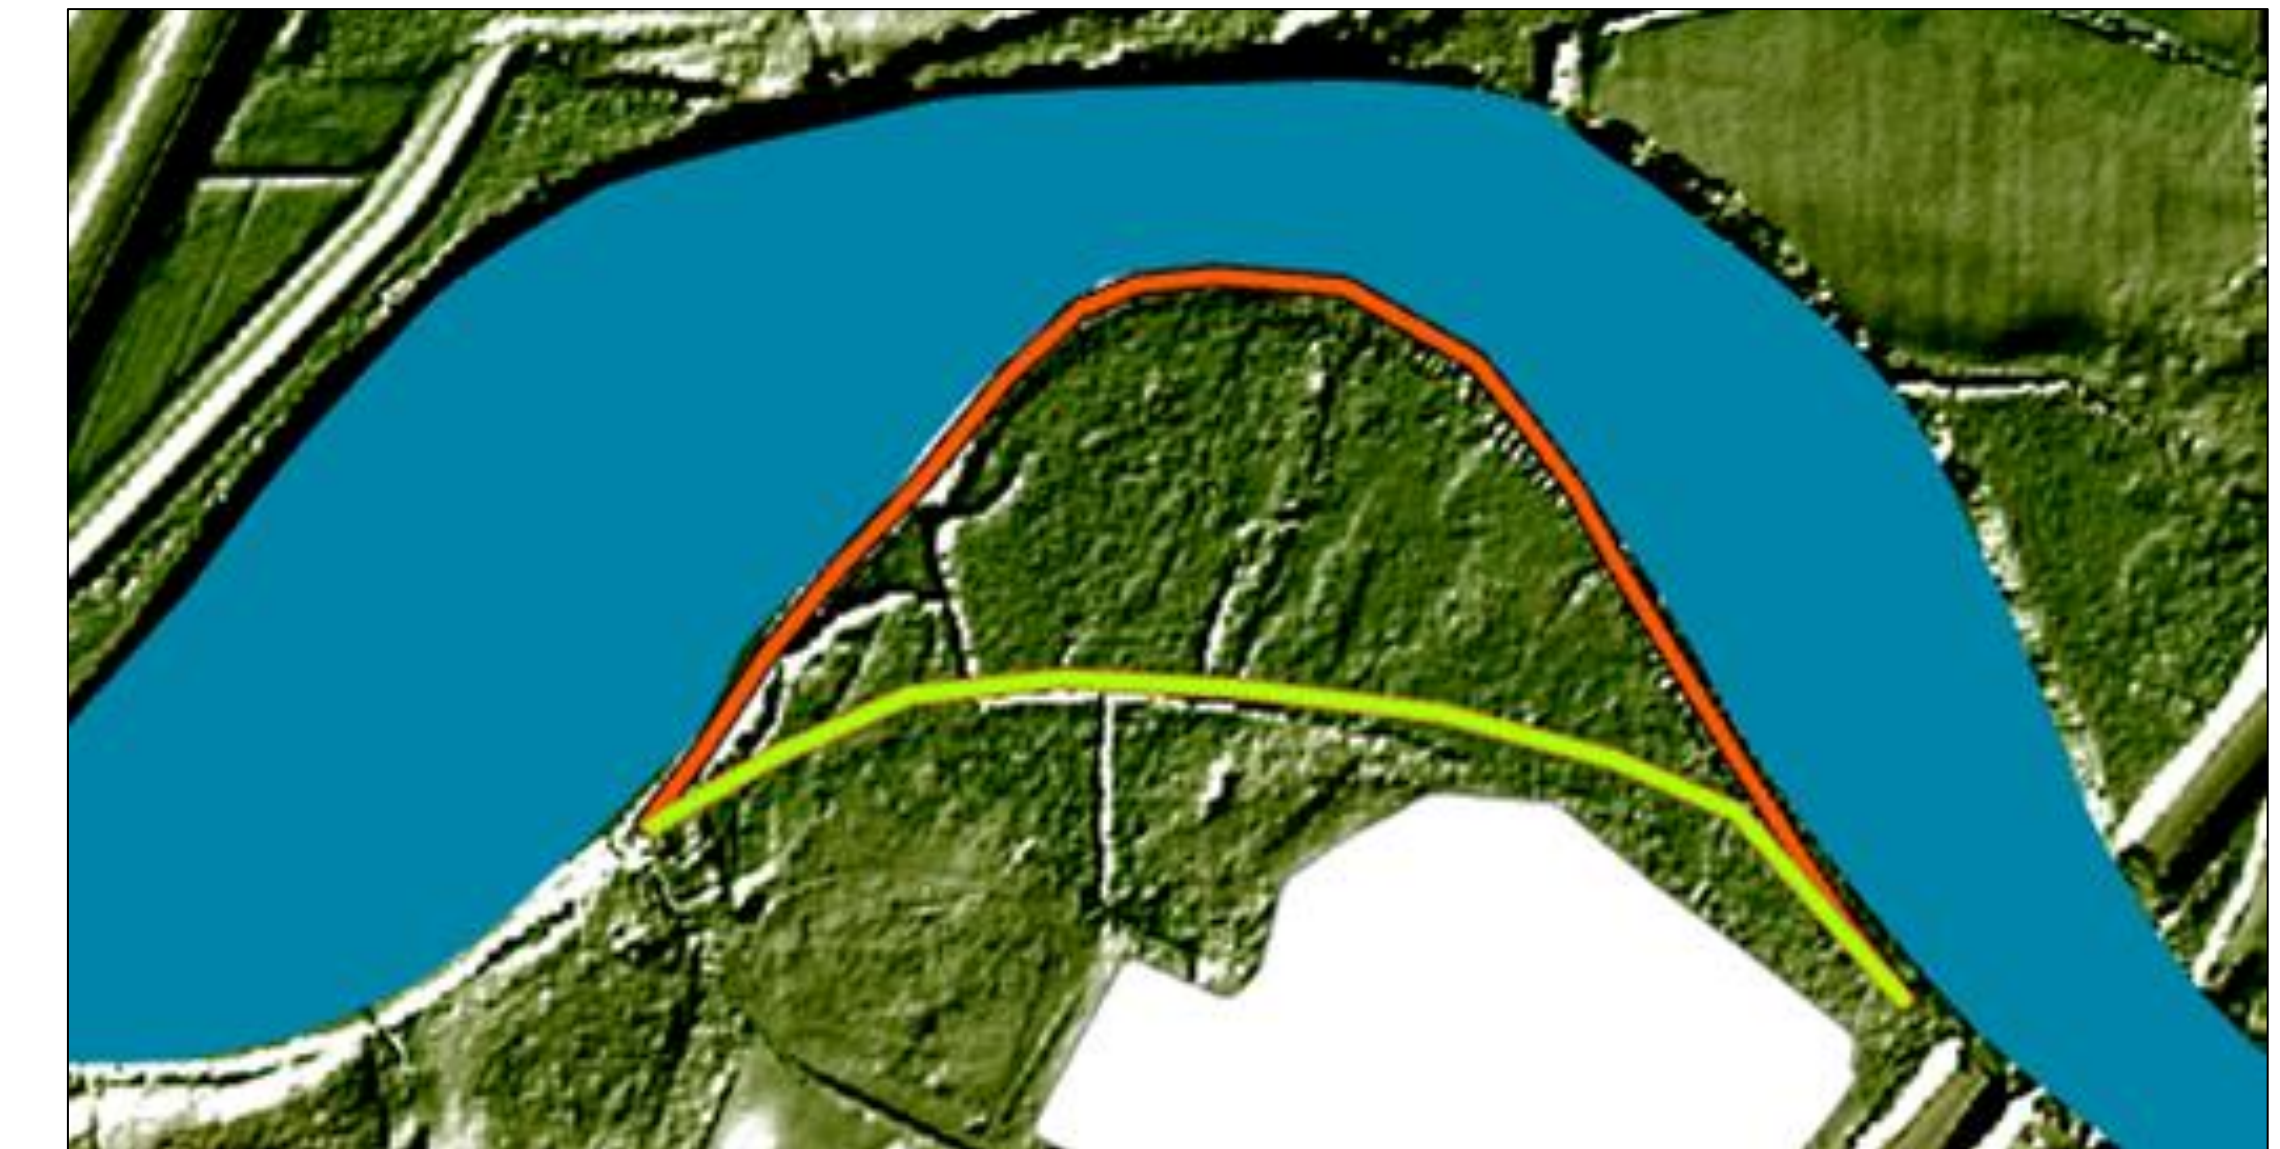
- The analysis for had the lowest FOS = 1.5 with a 3:1 slope.
- Tried to place a 2:1 slope facing the water, however, the slope failed with a FOS = 1.132.

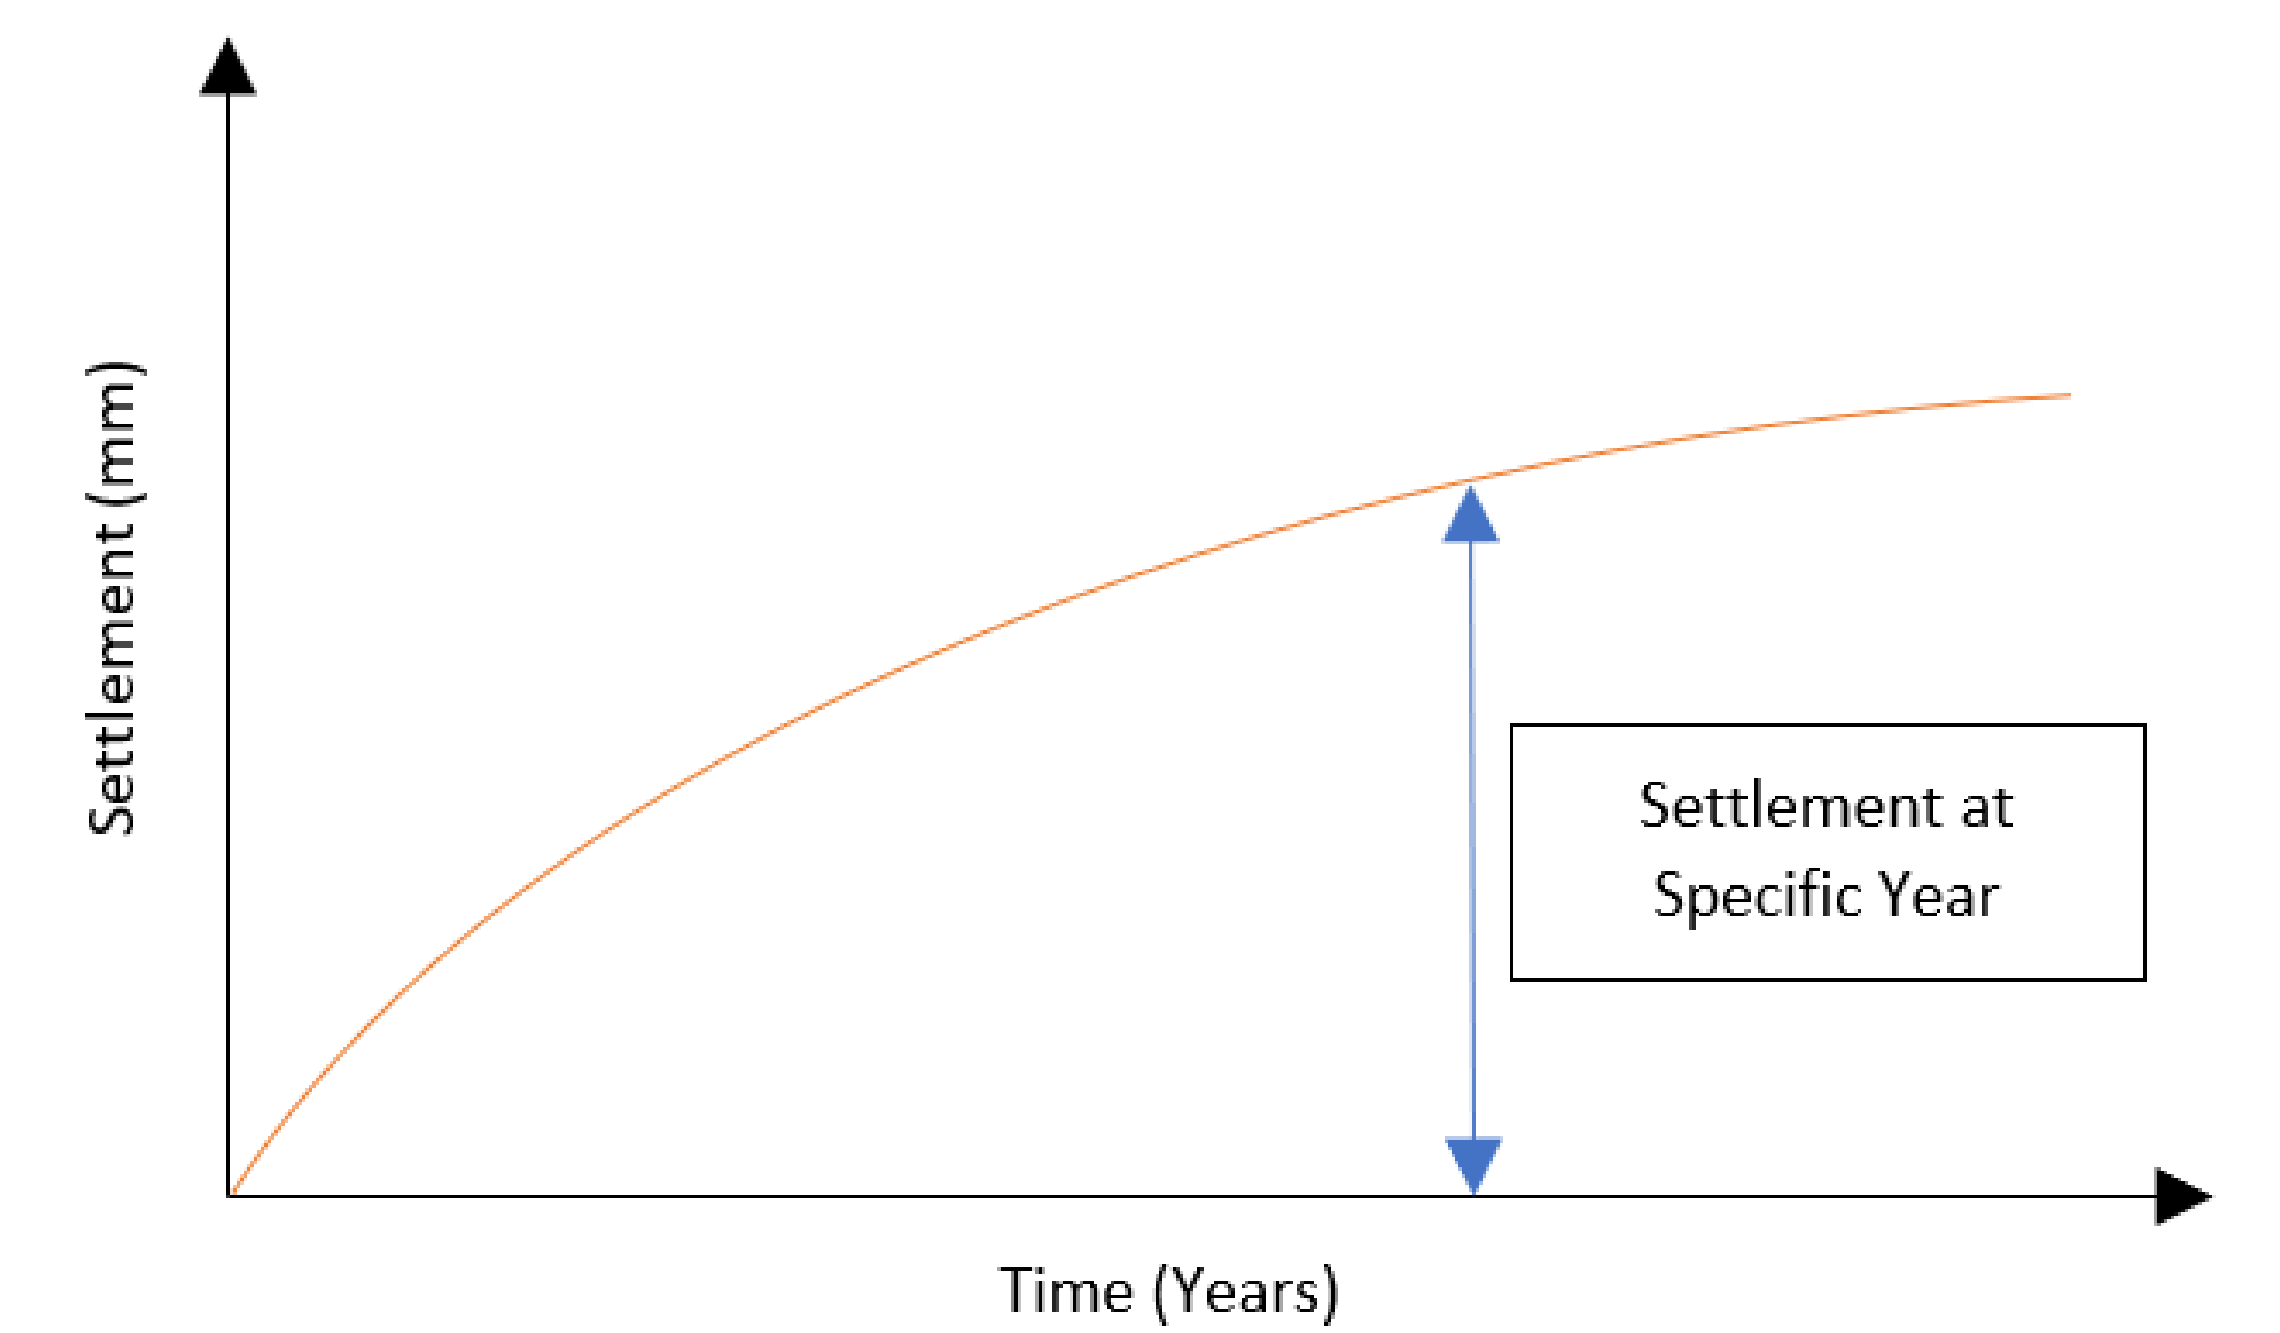
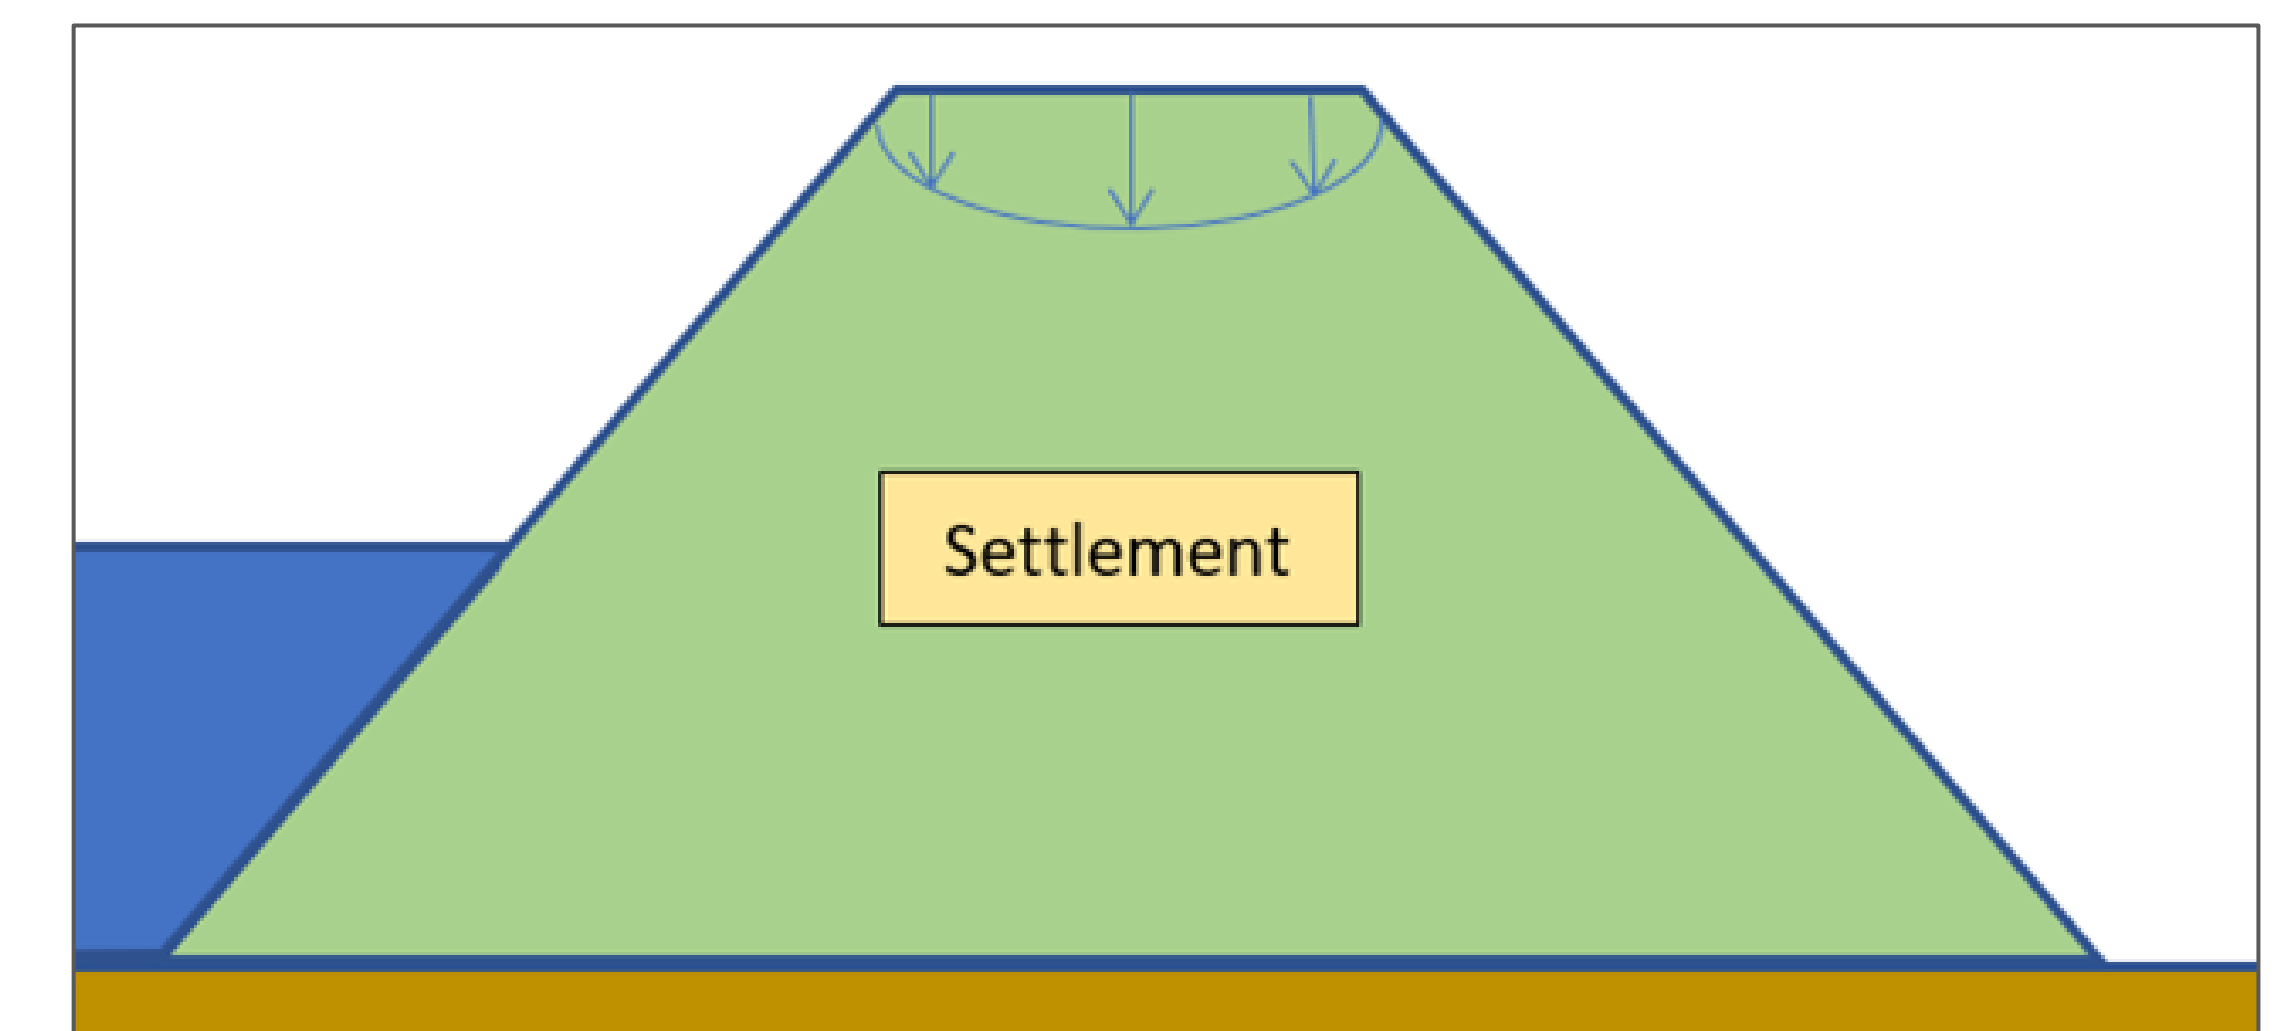
- The settlement must be calculated at three points of the dyke.
- The period of time at which the settlement occurs must be calculated.
- The settlement and time period calculated will determine when the dyke should be topped up.
