## **Dalhousie University, Department of Facilities Management**

## **Confined Space Inventory Form**

Building: Studly Gym C600	Room Number: Operators Room	Date: <u>July 04, 2013</u>		
Confined Space No: C600 - OR - 01	Confined Space Class:			
Description of Space: <u>Domestic Hot Water Tank</u>				
Located in the Operators Room of Studly Gym, opposite the main electrical room.				
Construction Material:				
Method of Entry: Ladder required for access.  No. of Access / Egress Points: 1				
Dimensions of Access / Egress Opening:				
Height: 11.0 inches Width: 15.0 inches				
Type of Work Normally Conducted in Space: Cleaning and relining of tank.				
Frequency of Work Performance: <u>As required.</u>				
Reference Atmospheric Testing: CO ppm	H <sub>2</sub> S ppm O <sub>2</sub>	% LEL%		
Other:

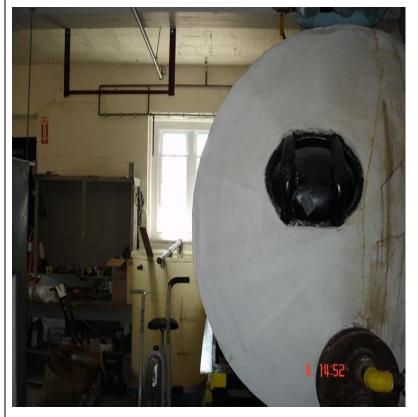
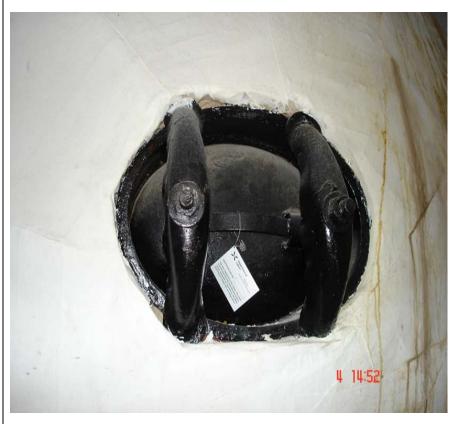
Photo Number: 2013 – 07 – 04 (1452)

Potential Hazards				
List all hazards near the access / egress opening(s) or in the confined space that must be controlled to ensure employee safety.				
Potential Hazards	Recommended Control Measures			
Oxygen Hazard:				
Quality of the air in the tank could be an issue.	Do air sampling prior to entry and implement all required control measures.			
Electrical Hazards:				
Mechanical Hazards:

Physical Hazards:	
Water Asbestos Heat Steam Lines	Isolate water lines and lock out. Sample concrete liner to determine whether there is asbestos. Ventilate inside of tank to ensure safe working temperature. Isolate and lock out.
Chemicals Hazards:	
Biological:	
Additional Comments:
